# An Historic Building Conversion to Research Usage and Post Occupancy Commissioning: Lessons Learned

Anand K. Seth , Partners HealthCare System, Inc.  
Teerachai Srisirikul, Partners HealthCare System, Inc.  
Michael Morrissey, Sebesta Blomberg Inc.  
David L. Stymiest, Smith Seckman Reid, Inc.

# Post-Occupancy Commissioning (Cx) Approach

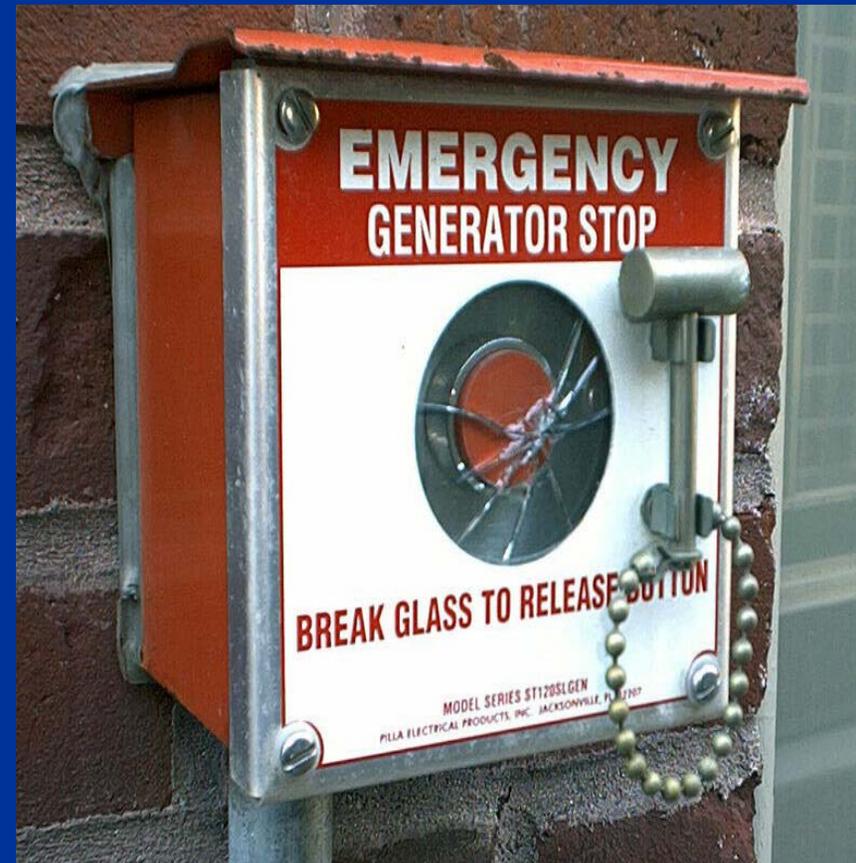
- ✍ The generator break-glass emergency shutdown switch on the wall near the generator set enclosure had cracked (almost broken through) glass in front of the button.
- ✍ When this glass weakens further and breaks, the generator would either fail to start or stop immediately.

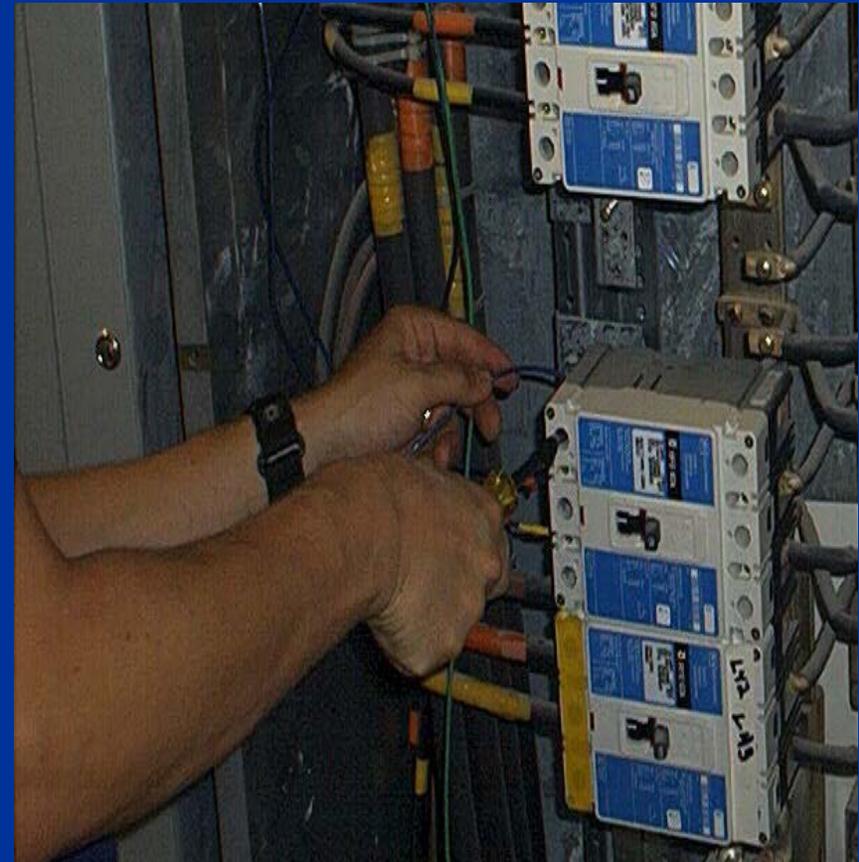
- ✍ This wire in a 480 volt normal power distribution panel was so loose that it was in danger of falling off the breaker.
- ✍ MGH's electrician fixed it immediately because of the hazard it represented.

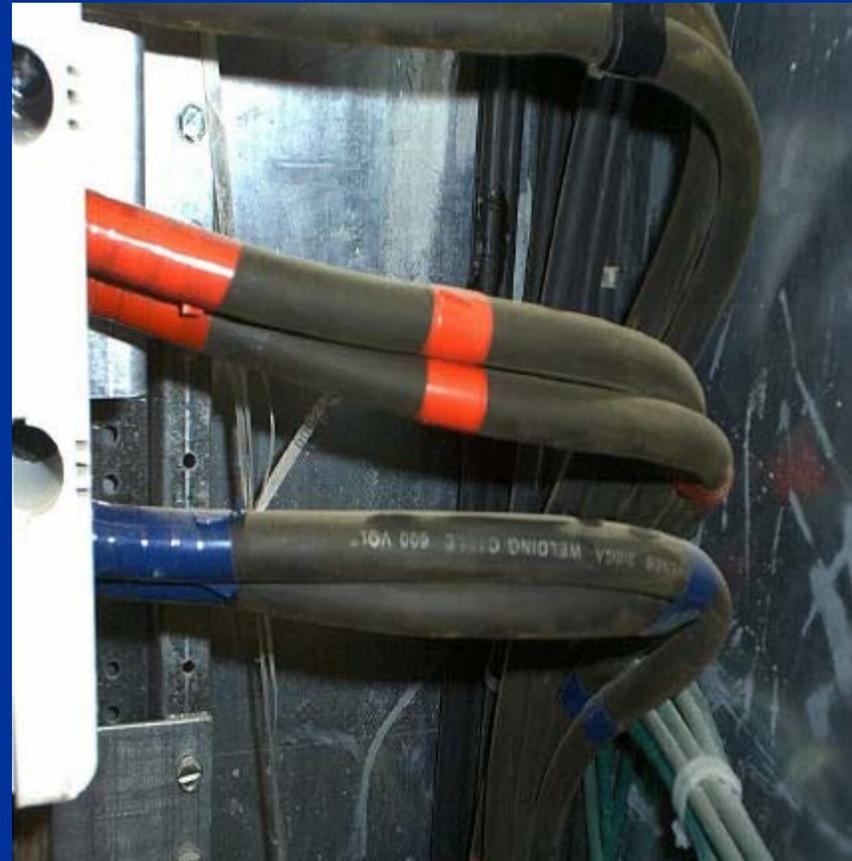
- ✍ Six panels were required to be Isolated Grounding (IG) type, but testing verified that they were not IG type.
- ✍ Several items of fire alarm extender equipment were powered by the equipment system rather than the emergency power (life safety) system.
- ✍ 225 KVA transformer primary and secondary feeders were found to be smaller welding cable installed in embedded conduit rather than the larger correct type of cable as required by CDs.

- ✍ The Contractor hired its own Code consultant to dispute our contention that this welding cable must be replaced.
- ✍ While the dispute was going on, MGH infrared-scanned the cable and proved it was overheating. MGH replaced the cable and subtracted the cost from the Contractor's retainage.

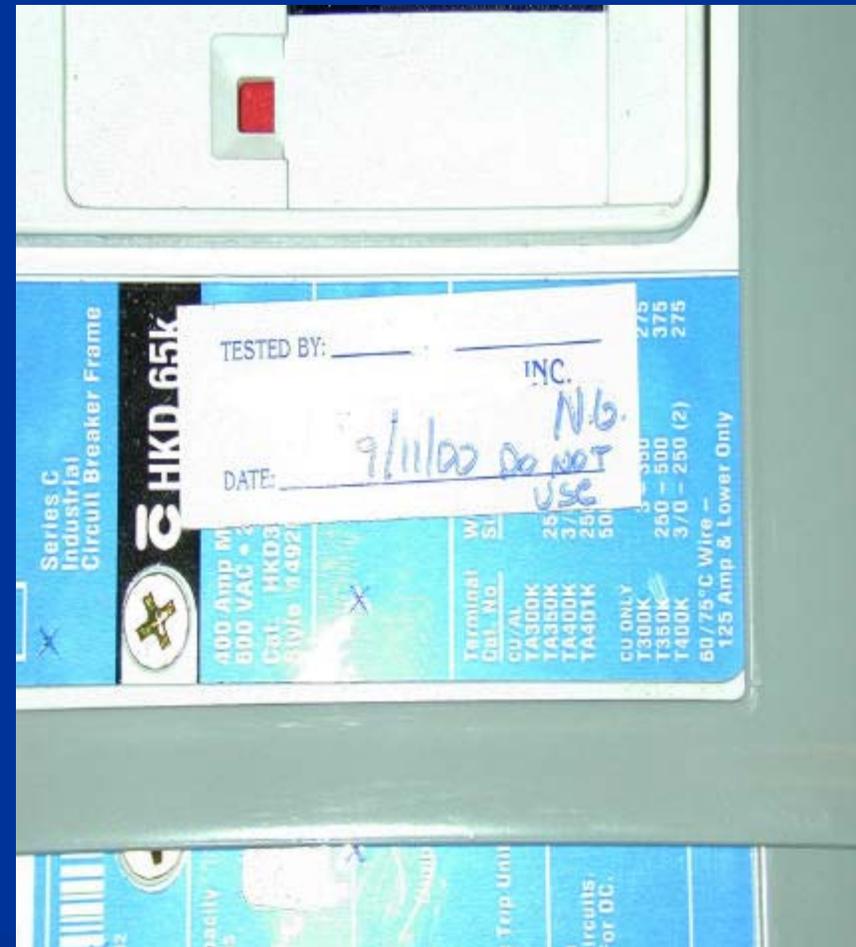
- ✍ Some findings from previous electrical testing had not been corrected despite Contractor's claims that corrections had occurred.
- ✍ This broken circuit breaker was still in use.
